CASE HISTORY
RAPID RESPONSE ASSEMBLY AND OPERATION OF A
TWO MILLION GALLON PER DAY ACID MINE DRAINAGE
TREATMENT PLANT
CROSSVILLE COAL PIT
CRAB ORCHARD, TENNESSEE₁

Don Budeit₂

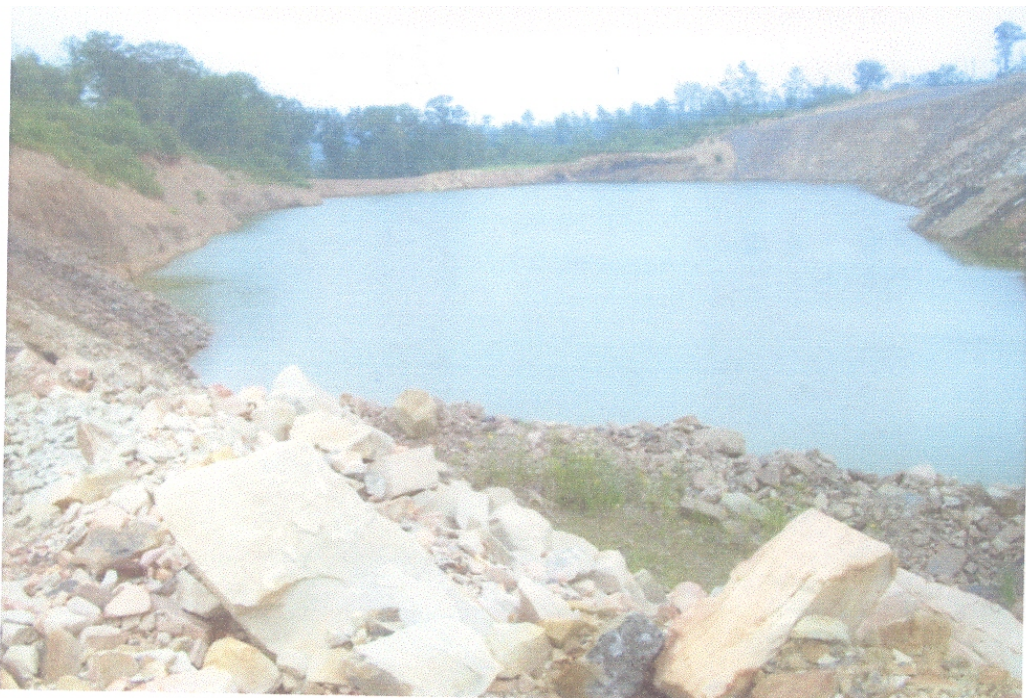
Figure 1. Crossville Pit Note the 10 foot berm that was placed at the far end of the pit. The pit is surrounded with acres of acidic rock and ground water is directed to the pit.

The pit covers an area of less than four acres, is 150 feet deep and was reported to contain 70 million gallons of 3.1 pH water containing 150 milligrams per liter iron and 148 milligrams per liter manganese.

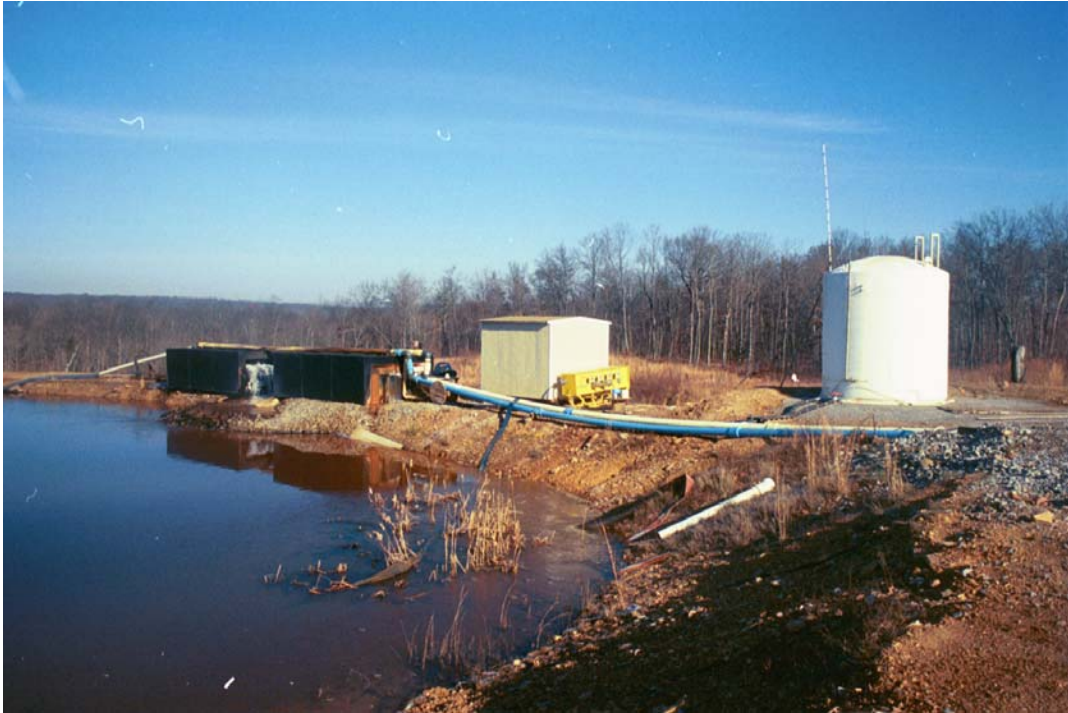
Figure 2. Tank at the right is the chemical tank. Building in the middle houses the pH control system. Long pipes feed each of the two systems separately. The two systems are the black high density polyethylene units at the left.

Totes containing 20% Sodium Hydroxide were eliminated and replaced with an insulated 4000 gallon tank containing 50% Sodium Hydroxide. An unused guard shack was appropriated to house the pH controllers. The diesel pump bring water from the pit was replaced with electrical pumps.

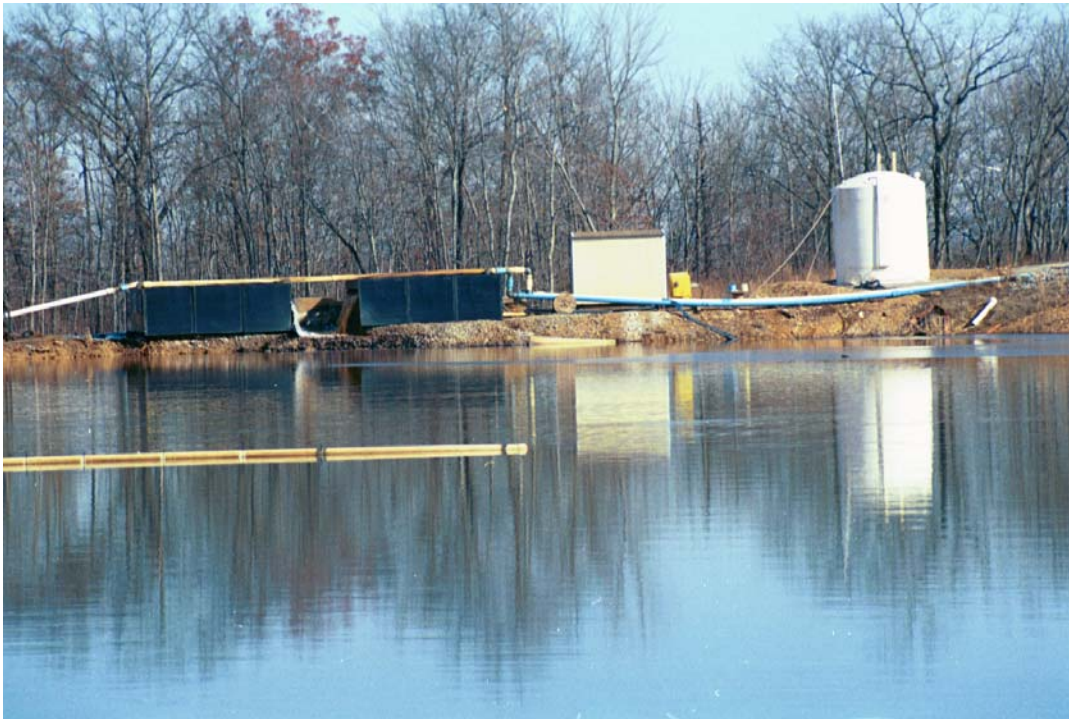
Figure 3. View of the treatment system on the bank of Surge Basin 2.
